Intel[®] Celeron[®] Processor Specification Update

Release Date: April 2008

Document Number: 243748-052

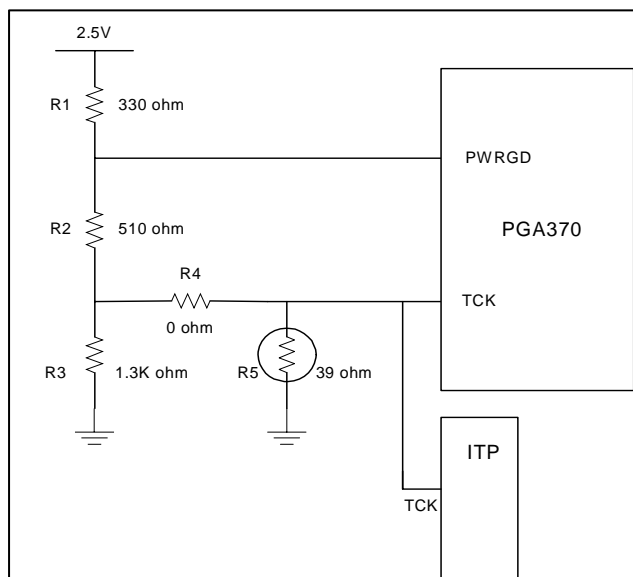
Figure 1 Celeron® on 0.13 Micron Processor 256K Platforms Workaround

In addition, the example workaround circuits shown do not support production motherboard test methodologies that require the use of the processor JTAG/TAP port. Alternative workaround solutions must be found if such test capability is required.

For Production Boards:
Depopulate R5

To use ITP:
Install R5, Depopulate R4
